**Agri-Mark, Inc. d.b.a. Cabot Creamery
Polished Permeate Spray Disposal System
2018 Annual Inspection Report
Indirect Discharge Permit # 9-0043**

May 2018

Re: Agri-Mark, Inc. d.b.a. Cabot Creamery, Indirect Discharge Permit # 9-0043
2018 Annual Inspection of Spray System
JCO # 1-0303-1

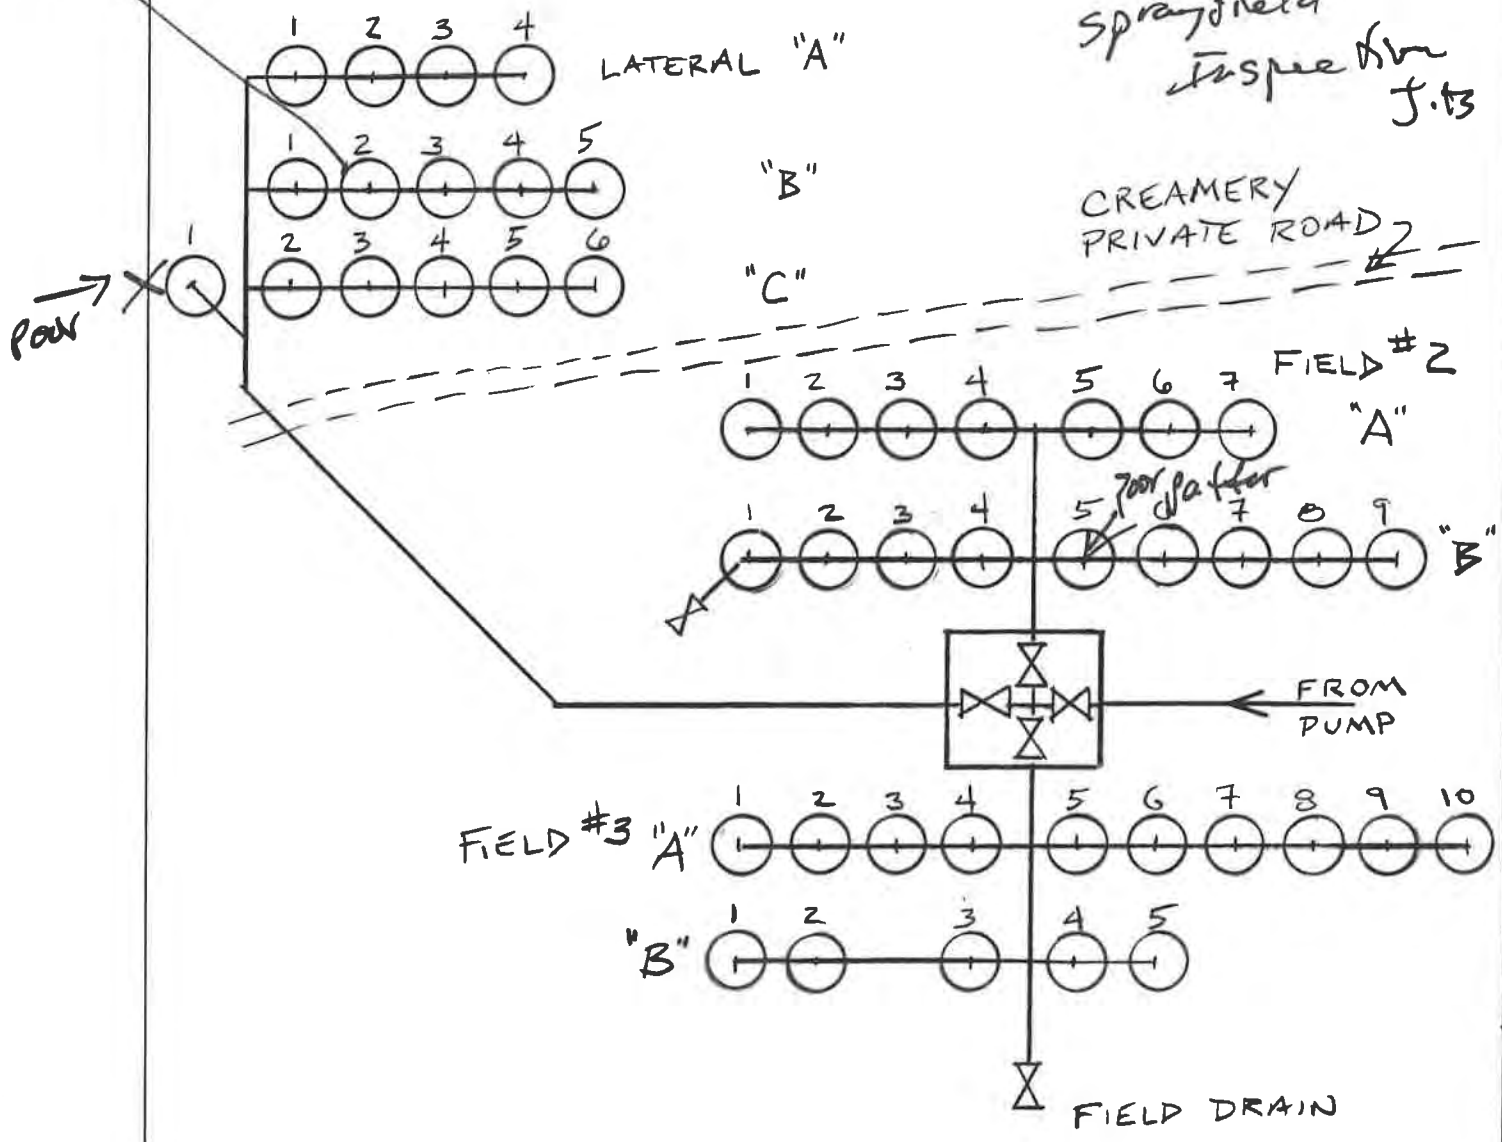
FIGURE 1

The spray disposal system was operated to inspect the spray heads. During the inspection it was observed that all sprinkler heads were in place (except for one in Field #1 B2) and all were operating properly with the exception of two sprinkler heads with poor spray patterns (Field #1 C1 and Field #2 B5 on attached Figure 1).

Leaky
Missing
Head

Sprayfield
Inspection
J.B.

1. Continue mowing and brush cutting activities on the storage lagoons. Inspect and monitor the force main drain headwall for movement. Replace the sod and restore the southwest corner of the embankment at Lagoon #3
2. Continue to maintain an operation log book for the spray irrigation pump system.
3. Install, replace or clean spray heads as needed for proper operation. Periodically observe the spray heads in operation and clean those noted to be improperly functioning.
4. Continue to cut back brush and trim trees around the spray fields.
5. Annually exercise the valves in spray field valve pit.
6. Fix the leak at the spray system drain at Lagoon #3.
7. Replace or repair the cover for the spray field valve pit.
