Agri-Mark, Inc. dba/Cabot Creamery Collection and Land Application System 2018 Inspection Report

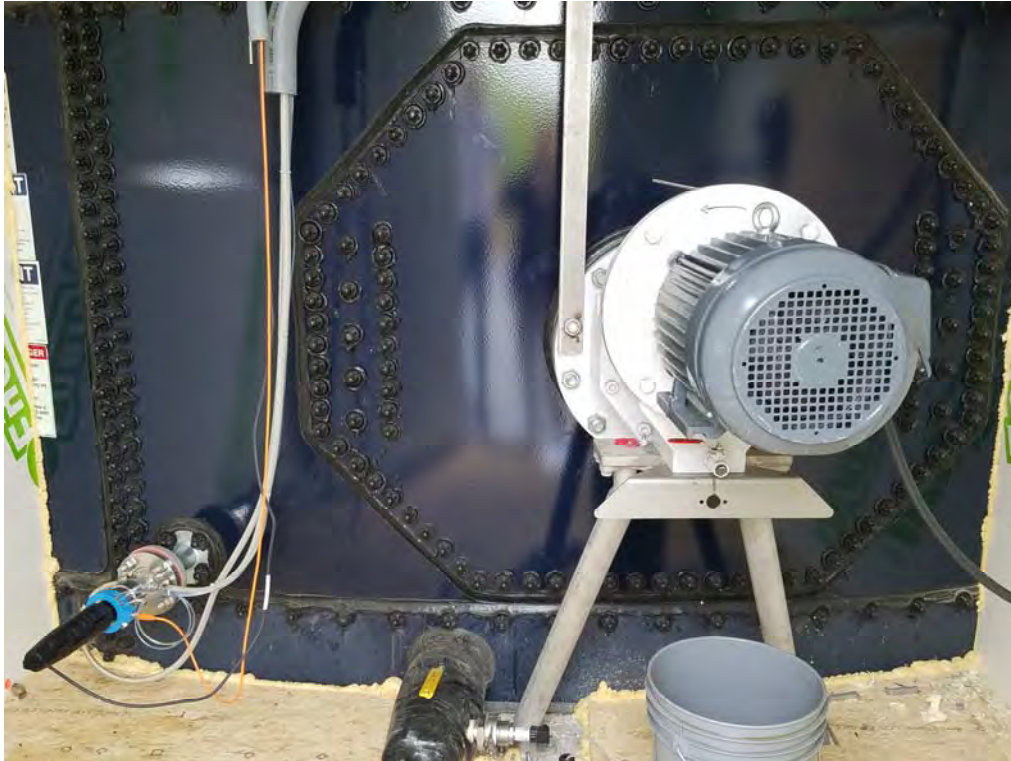
Storage Tank 1: pH probe and Agitator, photo taken by Kim Watson, 5/22/2018

1. Under the direction of the Cabot's Environmental Engineer, Aaron Page, Cabot installed a pH buffering system which provides continuous in-line metering, monitoring and buffering of the washwater pH. Additionally, a pH monitoring system was installed along with an automatic agitator inside of the newer storage tank.
2. As notified to the agency, the following cleaning chemicals were added; Passage (Floor Treatment) and Dry Bleach (Specialized cleaning agent). Sustain No. 464, Enhance, Hydriflux A No. 371, Iodosan No. 485, Ultrasurf and Security Floor Treatment previously reported are no longer in use at either facility.

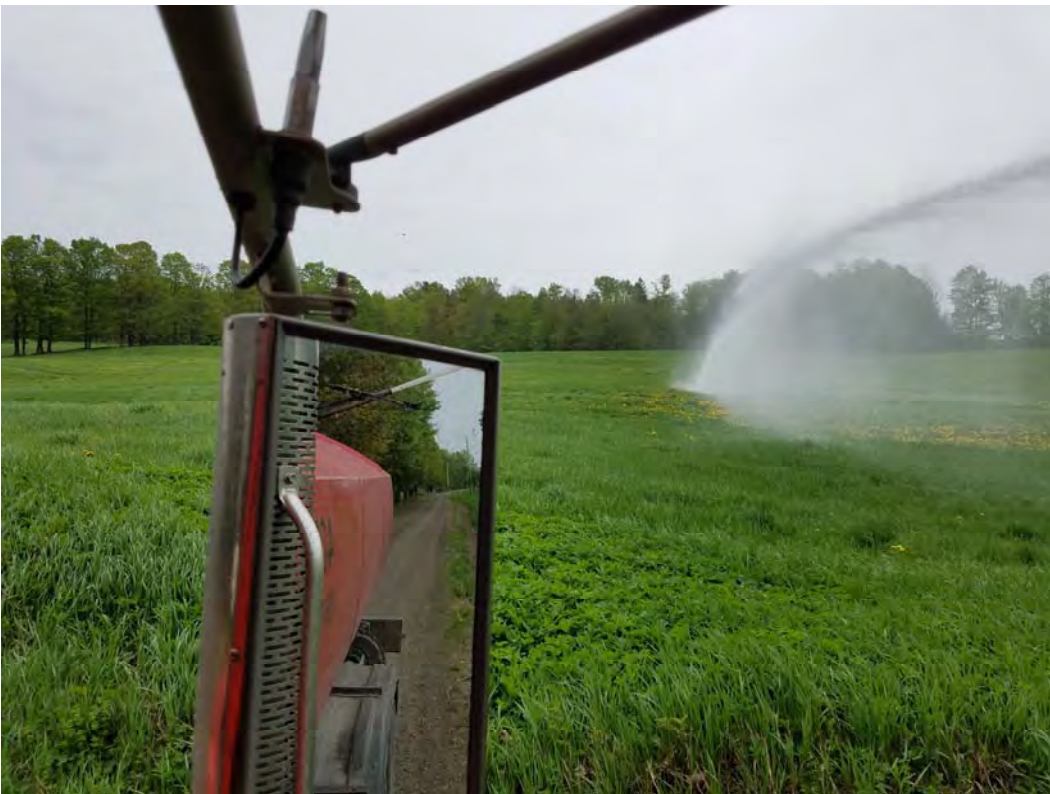
Land application, Field 71G. Photo taken by Kim Watson, 5/22/2018
